6
National Dam Inspection Program

DUNMORE ~~NO~~ 1 DAM

Number
PHASE I INSPECTION REPORT,
NATIONAL DAM INSPECTION PROGRAM

11
FEBRUARY 1979

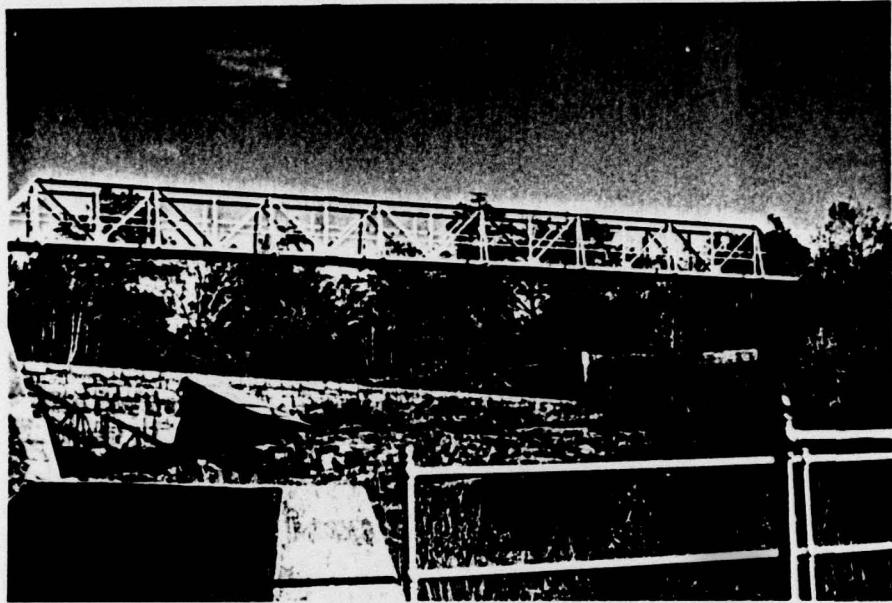
C. Spillway

c. Appurtenant Structures. The spillway is in generally good condition (Photograph C). The mortar in the masonry spillway joints is slightly deteriorated. The bottom of the spillway outlet channel is mostly bedrock (Photograph D). Many small seeps were observed coming through the rock. There is a small dry masonry wall along a short reach at the left. The right side of the channel is a concrete gravity wall which retains the embankment and also acts as a training wall. The wall is slightly spalled at the top. Pattern cracking and leaching were observed at one monolith (Photograph F). The spillway channel narrows and passes under a small bridge that provides access to the toe of the embankment (Photograph D). The dimensions of the bridge are presented in Appendix C.

(3) Appurtenant Structures. The deteriorated mortar in the masonry spillway joints is probably caused by exposure to flowing water. The deterioration is not severe. The seepage from the cracks in the bedrock in the bottom of the spillway channel is not excessive.

(6) Visually monitor the spalling, cracking, and deterioration of the concrete and masonry joints. Take remedial action when needed.

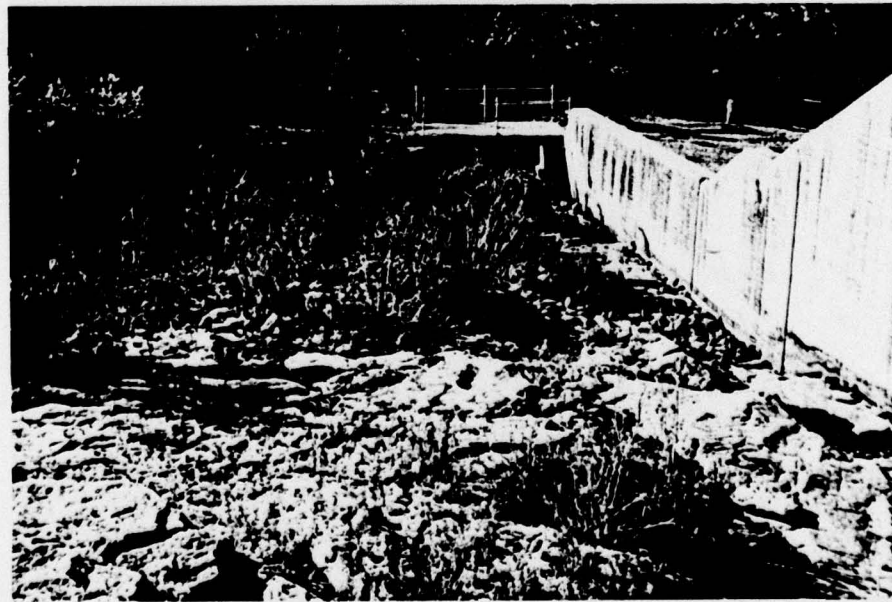
D. Spillway Outlet Channel

(5) Downstream Conditions. As indicated by the calculations in Appendix C, the peak spillway discharge cannot pass under the bridge that is located at the toe of the dam. The bridge would overtop, presenting an erosion hazard to the toe of the embankment. The available drawings note that the fill to the left of the bridge was loosely placed. It may have been the intent to allow this fill to erode during substantial spillway flows. This would alleviate the situation, but the bridge would still overtop for larger spillway flows. It appears that it would have been better to

(5) Perform additional studies to determine the erosion hazard caused by the small bridge at the downstream end of the spillway channel. Take remedial action as needed.

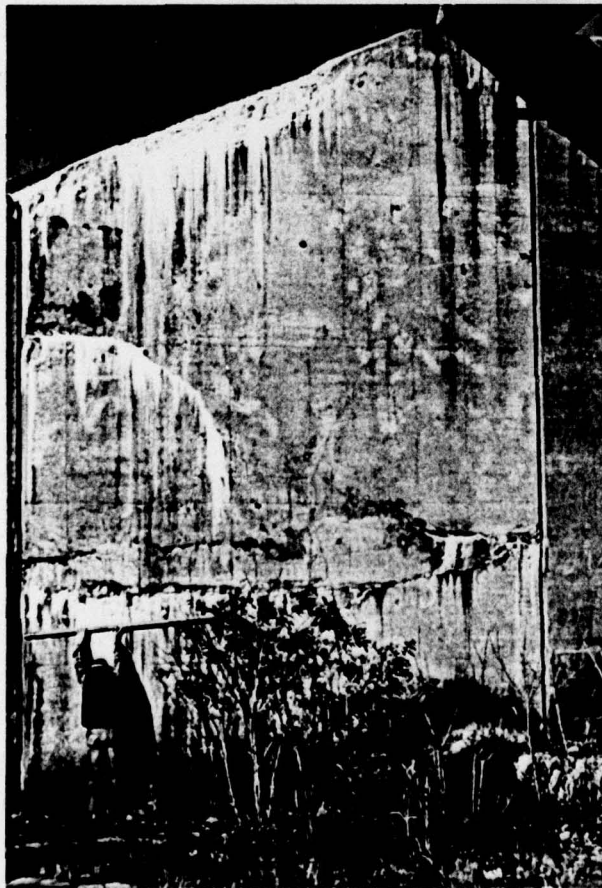
F. Crack in Wall
on Right of Spillway Outlet Channel

The spalling along the top of the spillway training wall is probably caused by long term exposure to the elements. The cause of the cracking and leaching on one of the monoliths of this wall is unknown, but it may be related to overfinishing of the concrete. Although it is not severe at present, further cracking would be of concern.

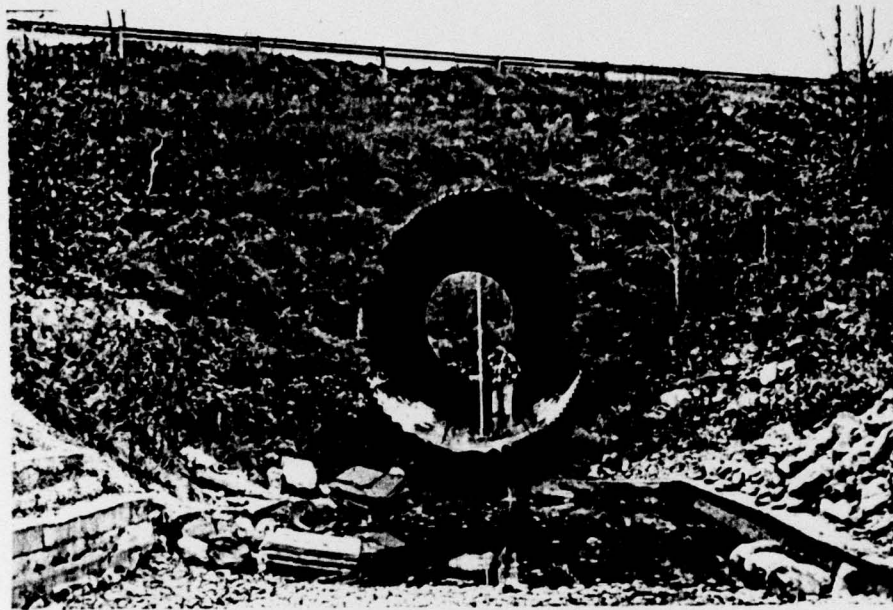
G. Culvert under Local Road

e. Downstream Conditions. The spillway channel proceeds downstream for 400 feet, where it passes through a culvert under a local road (Photograph G). Within 100 feet of the outfall, the stream enters a culvert which passes under Interstate 380 (Photograph H). The dimensions of the culverts are given in Appendix C. The stream then proceeds directly through a part of Dunmore. Dwellings are located close to the low stream banks. Both the local road and Interstate 380 extend

The backwater effect from the two culverts downstream from the dam will probably reduce the spillway capacity. The flooding pattern downstream from the dam is very complex. It appears that flooding would occur in Dunmore before the culverts were flowing full. As noted in the computations in Appendix C, the culverts will develop pressure flow at a much lower discharge than the spillway capacity of the dam. At discharges below spillway capacity, water will commence to discharge through the underpass at the left side of the valley. At higher stages, water will then begin to discharge over Interstate 380, near its interchange with Interstate 81. The computations indicate that a significant backwater effect will occur at the spillway. The spillway capacity will be reduced by 4 percent. This reduction in spillway capacity is reflected in the 9,600 cfs used for this study. It must be emphasized that these computations were based on estimated elevations. The actual effects could reduce the spillway capacity by a much greater percentage.

c. In addition, it is recommended that the Commonwealth of Pennsylvania require that the owner(s) of the culverts downstream from the dam perform a study to determine the effects of the culverts on the safety of the dam and that the owners be required to perform necessary remedial work if the culverts are found to affect the safety of the dam.

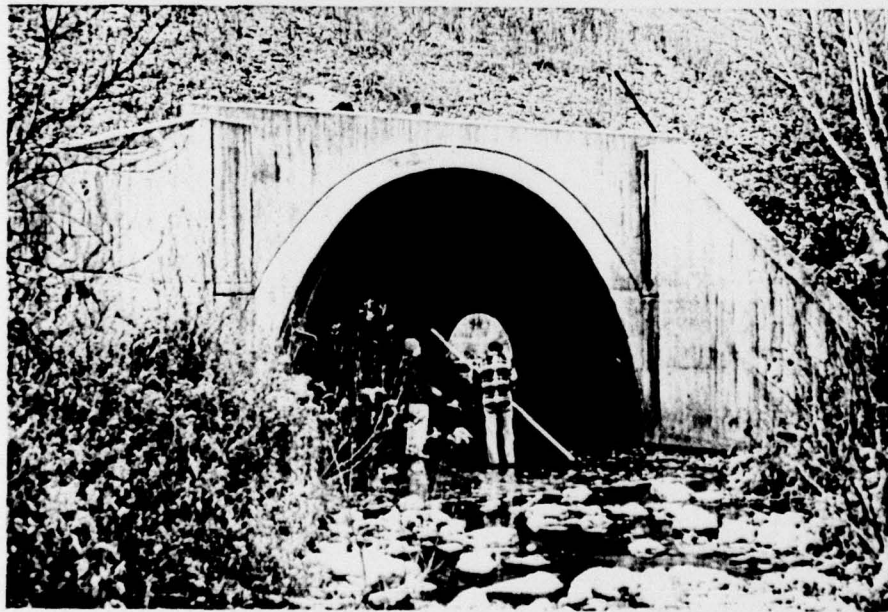
H. Culvert under Interstate 380

Note: Both culverts are immediately downstream of the dam.
